Finding Corbin's Colors: The Intriguing Results of Paint Detective Work at The Cupola House

April 4, 2025

Susan L. Buck, Ph.D., Conservator and Paint Analyst

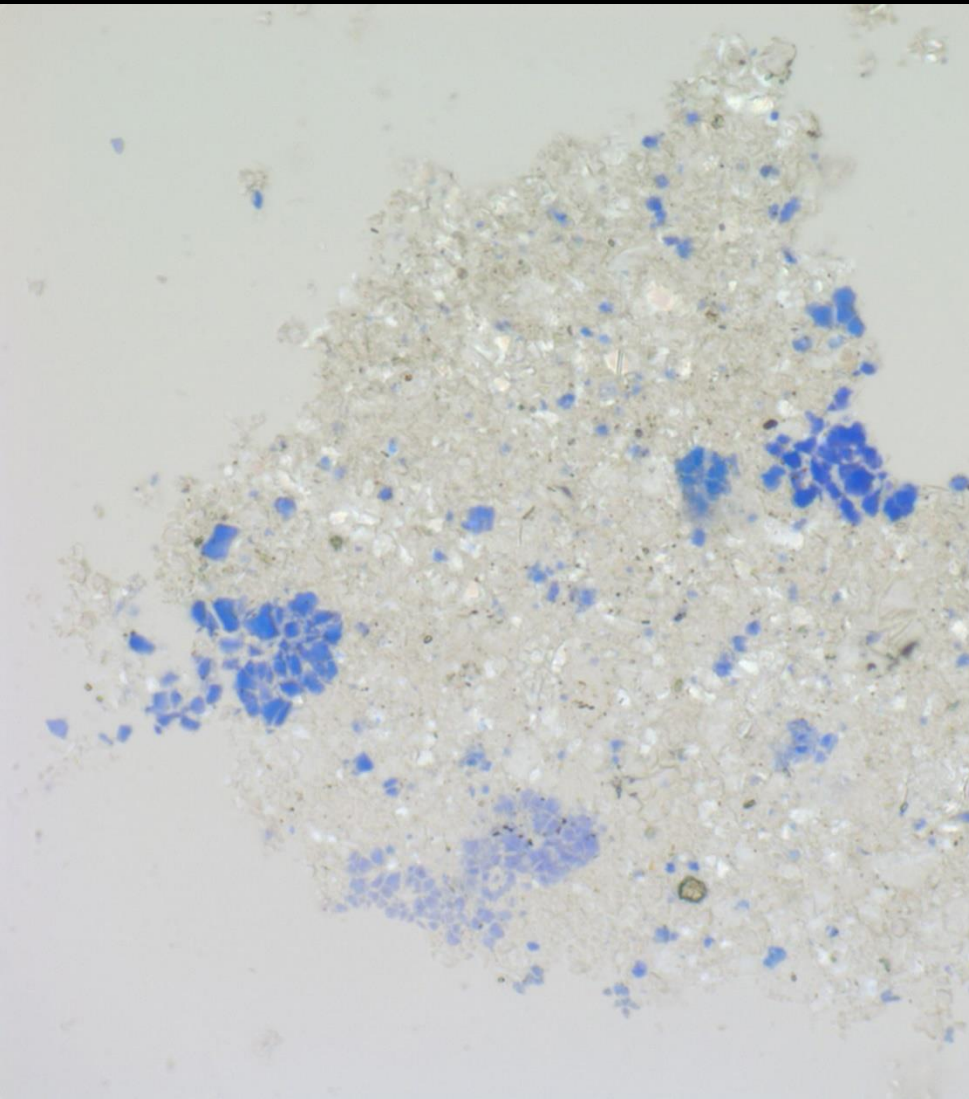
Sample 103-12. Synthetic Ultramarine In Blue Distemper

Plane polarized transmitted light 1000X

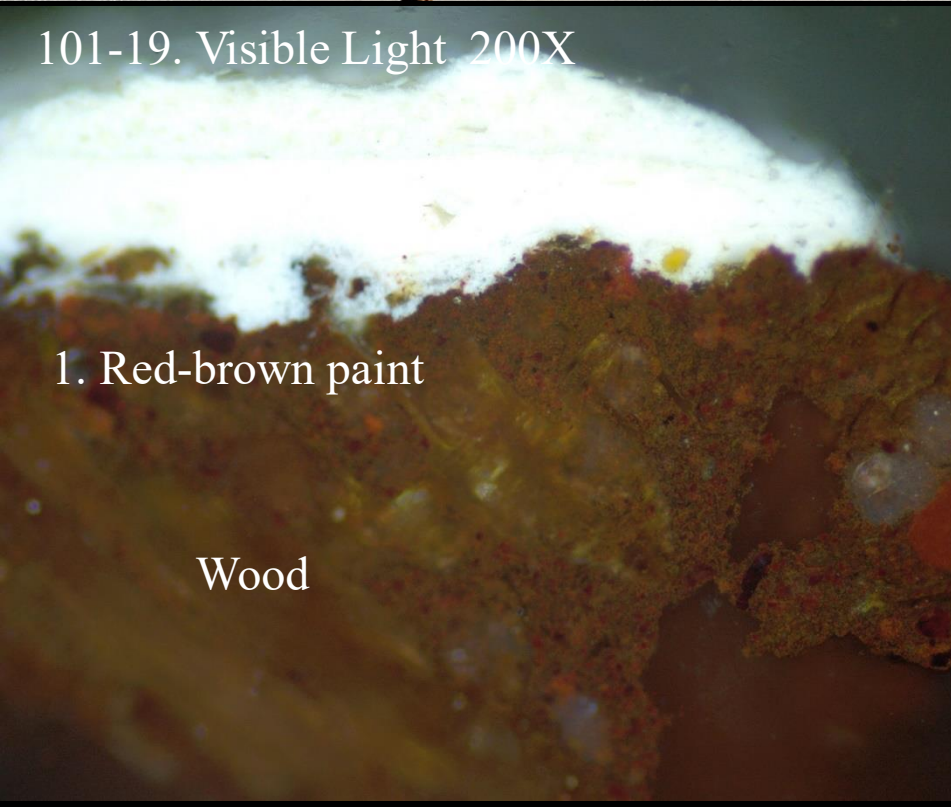
101-19. Visible Light 200X

1. Red-brown paint

Wood

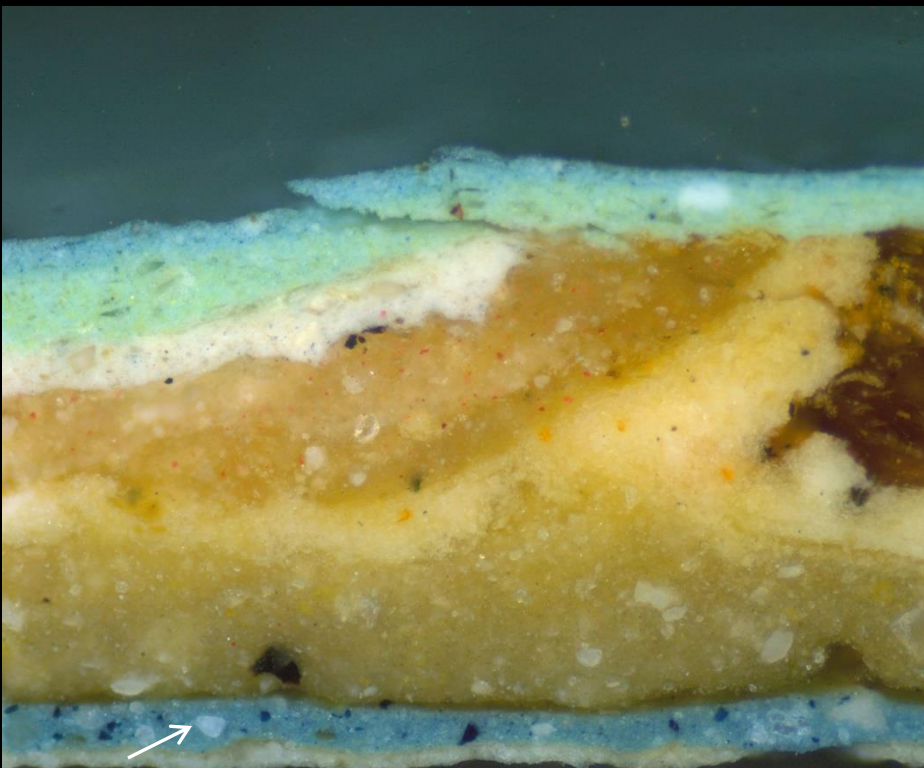
102-16. West wall door
Visible Light 200X

1. Blue with glaze on off-white primer

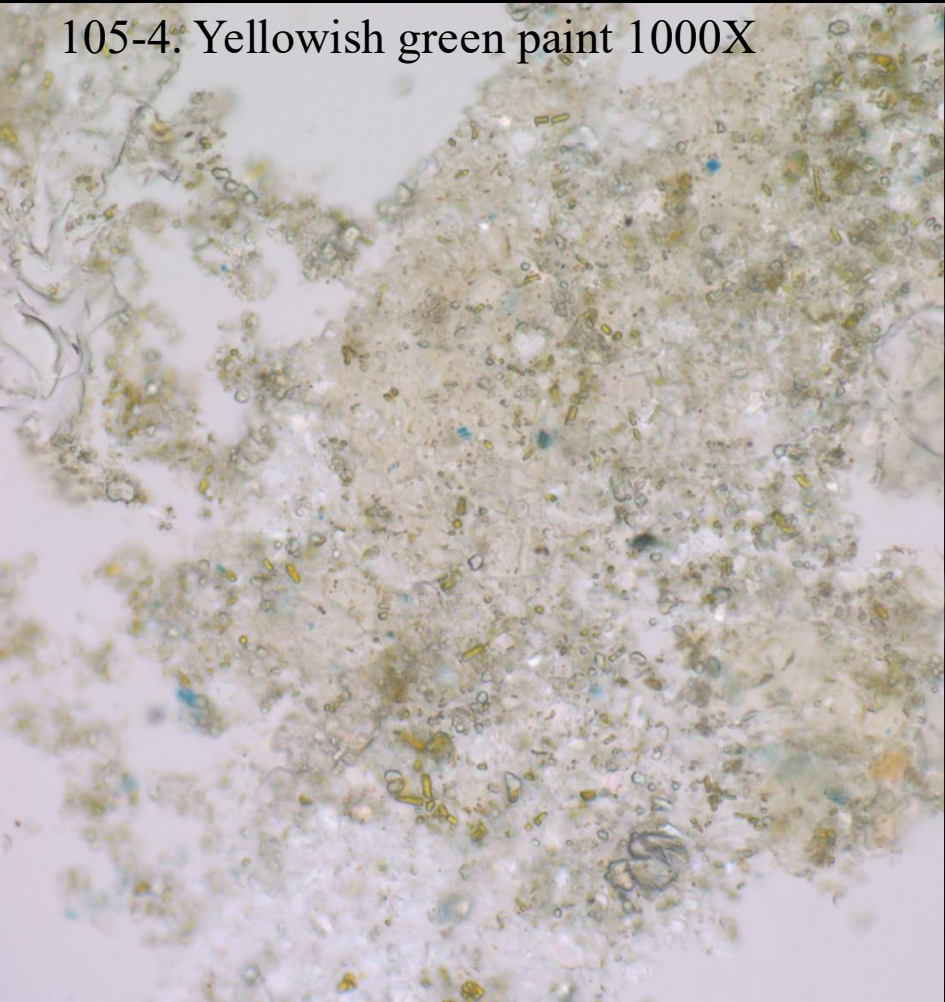
105-4. Yellowish green paint 1000X

Chrome yellow, Prussian blue and white lead in the second-generation yellowish-green paint

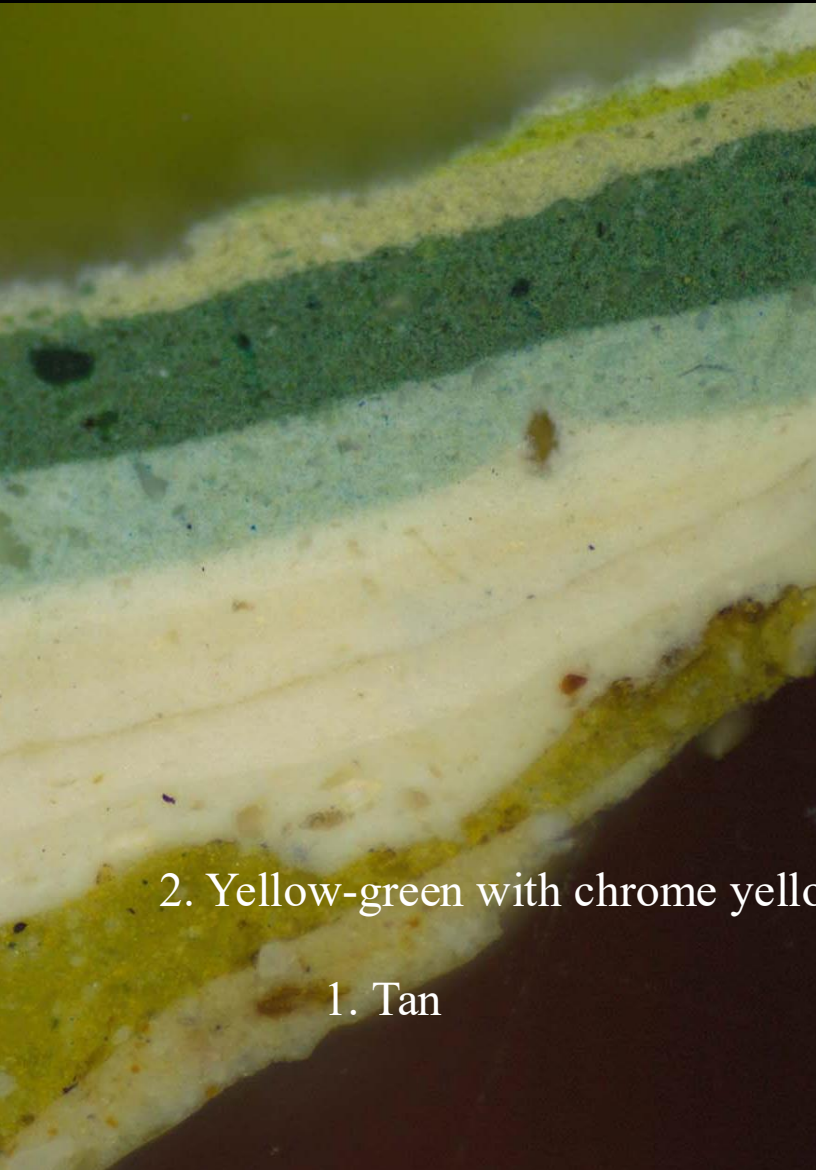
SW-1. Overmantel 200X

2. Yellow-green with chrome yellow

1. Tan

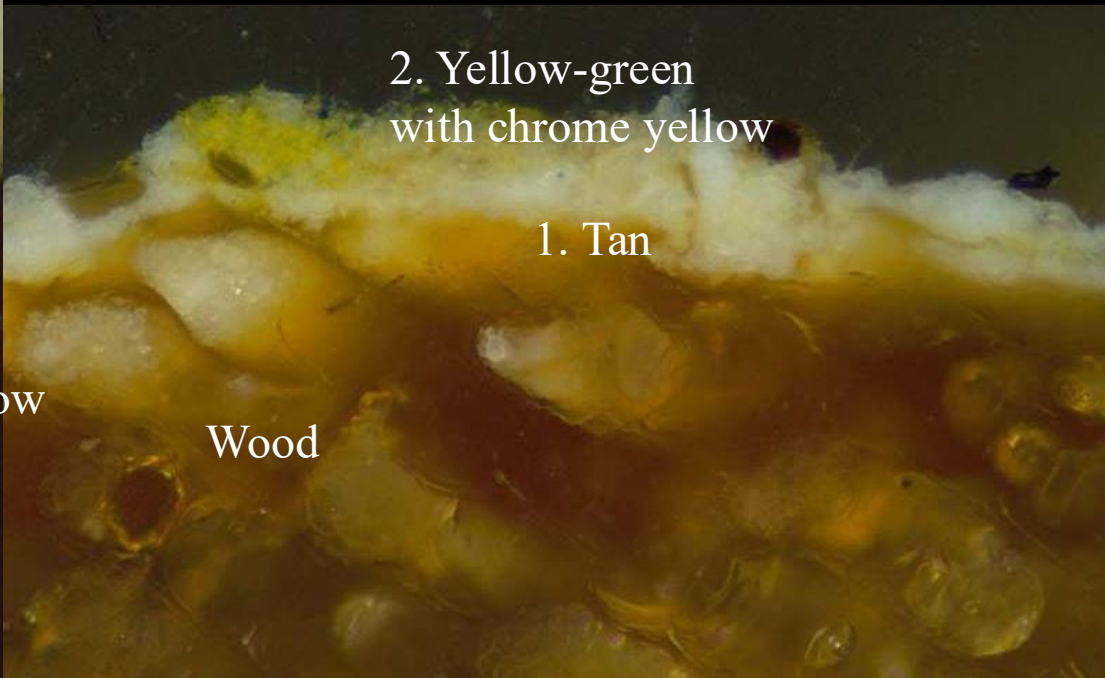
SW-2. Chair rail 200X

2. Yellow-green
with chrome yellow

1. Tan

Wood

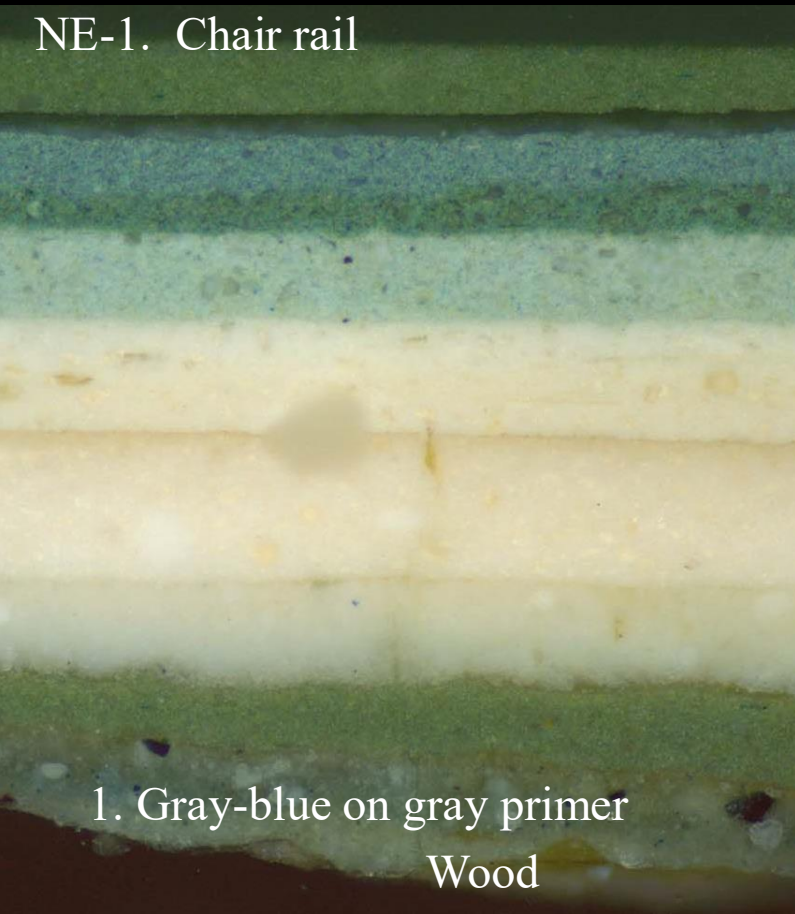
Room 204 NE Chamber
NE-1. Chair rail

1. Gray-blue on gray primer
Wood

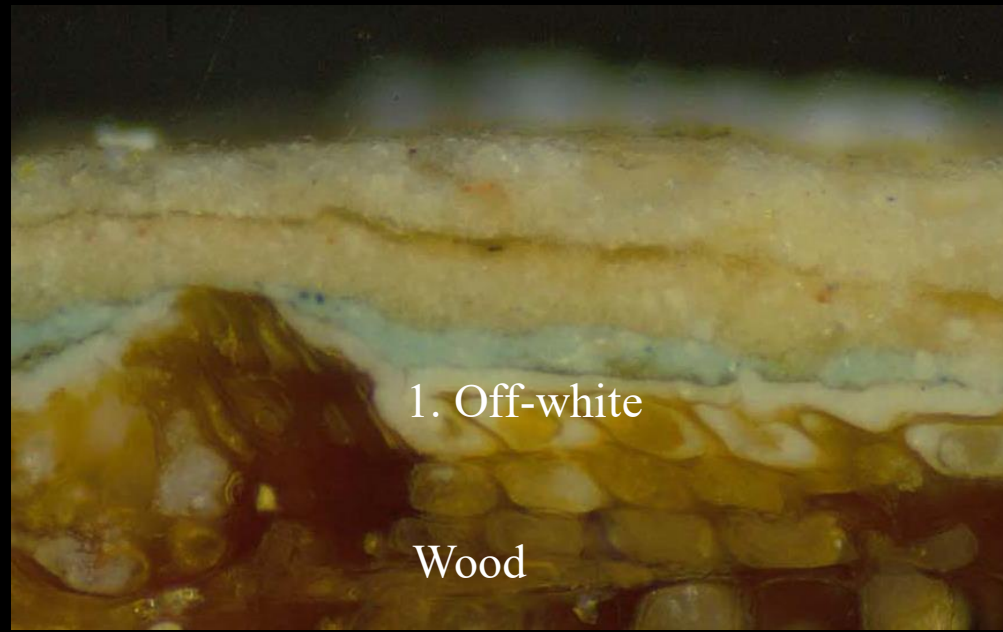
Room 205 NW Chamber
NW-1. Cornice

1. Off-white

Wood
