Finding Corbin's Colors: The Intriguing Results of Paint Detective Work at The Cupola House

April 4, 2025

Susan L. Buck, Ph.D., Conservator and Paint Analyst

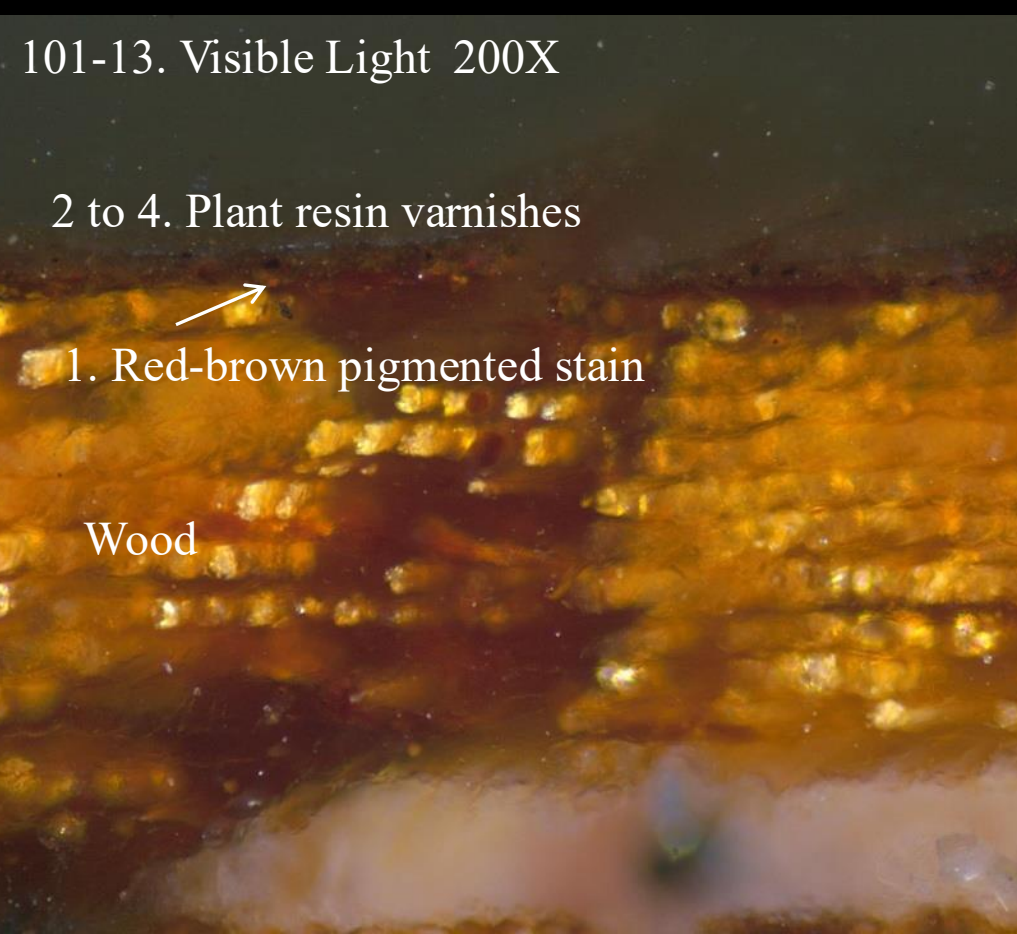
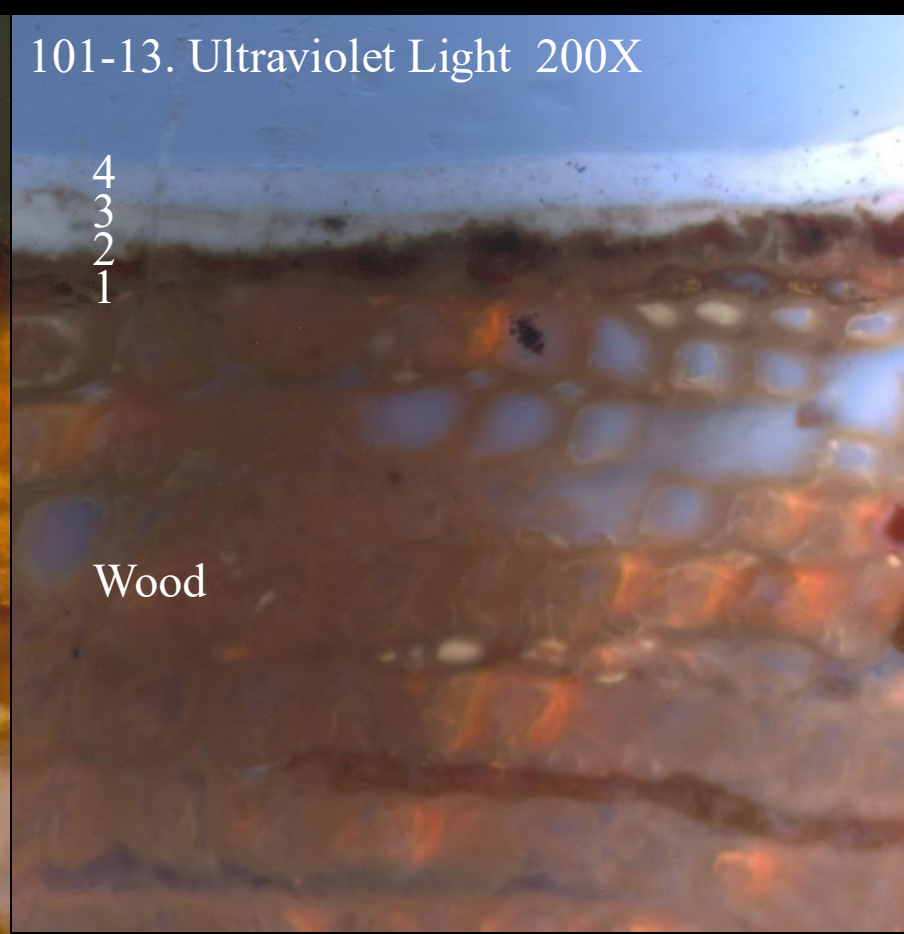
Room 101 Newel Post at Landing Above ghost of handrail

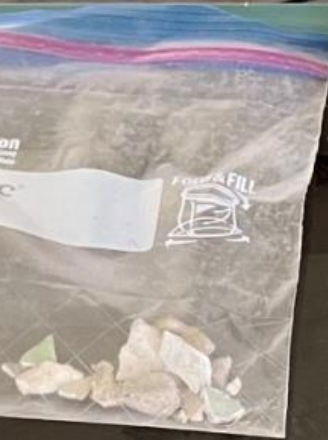
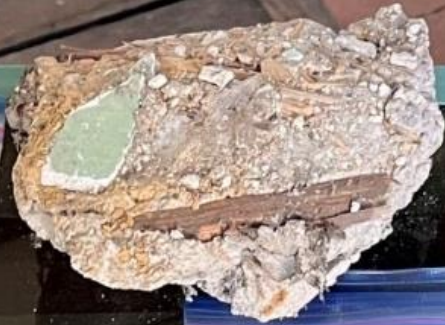
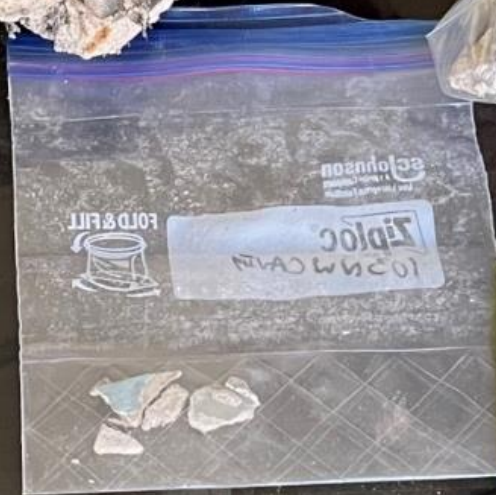
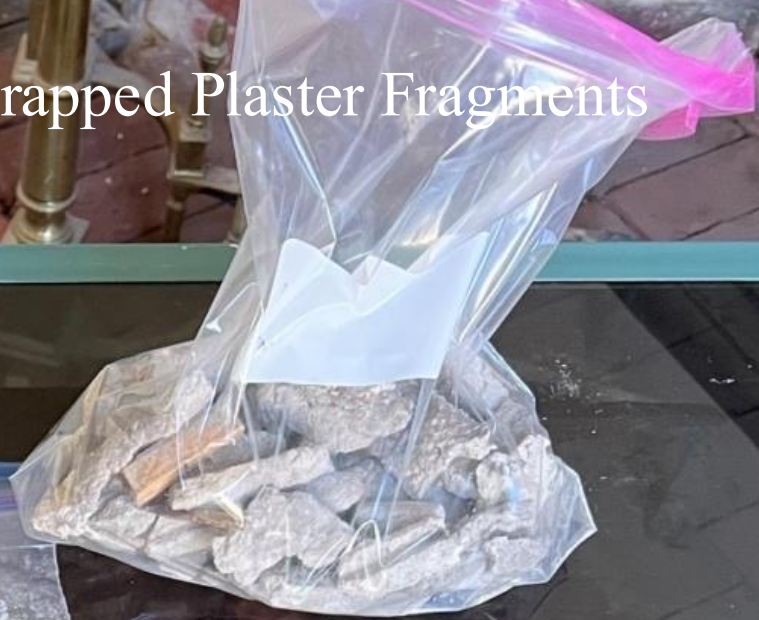
Rooms 103 and 105 Trapped Plaster Fragments

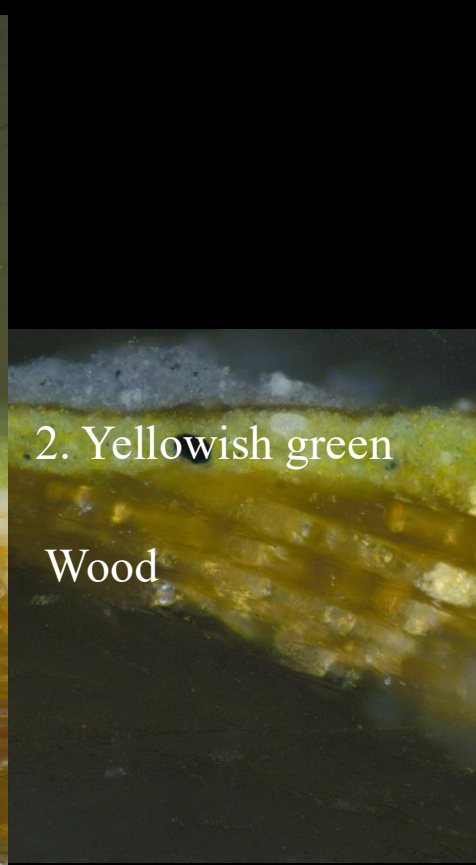
105-5. Mantel

2. Yellowish green on mantel

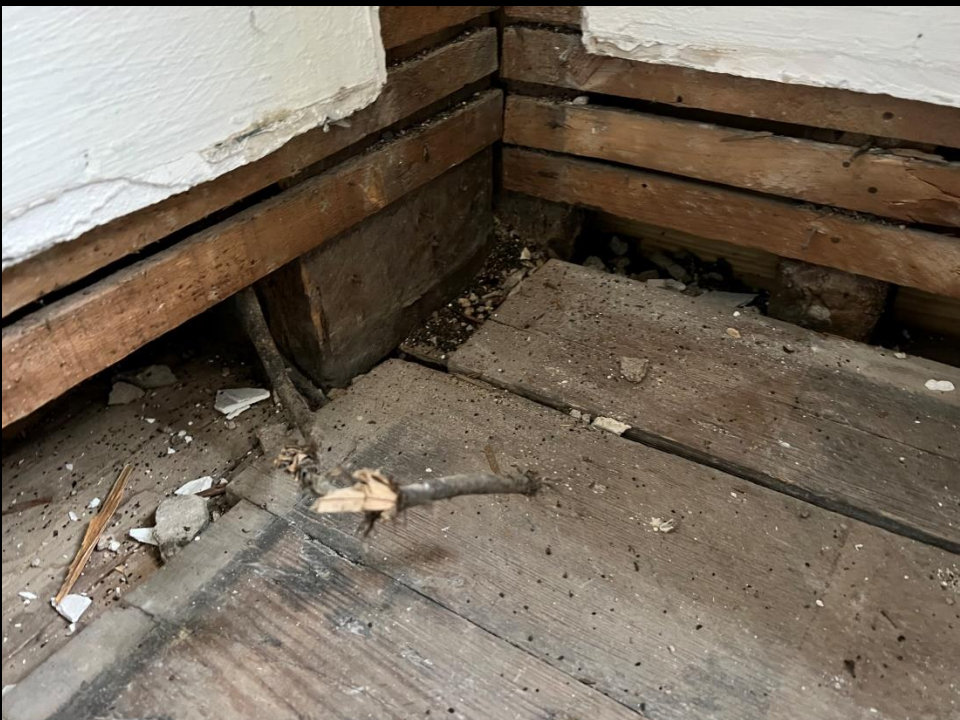
Trapped fragments and rat nests

Room 105 Rear NW Room Trapped Plaster Fragments

105-7. Fragment with green paint

16. Green distemper
15. Gray distemper

1 to 14. Unpigmented limewashes

105-7. Fragment with blue paint

12. Blue distemper
11. Yellow distemper
10. Gray distemper

1 to 9. Unpigmented limewashes

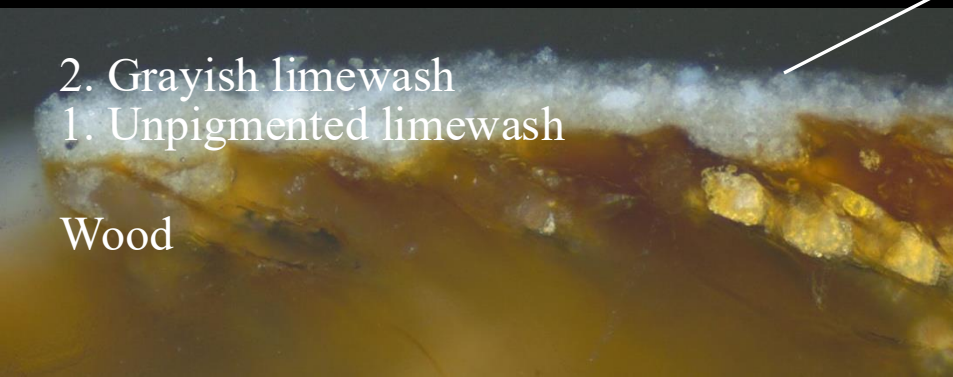
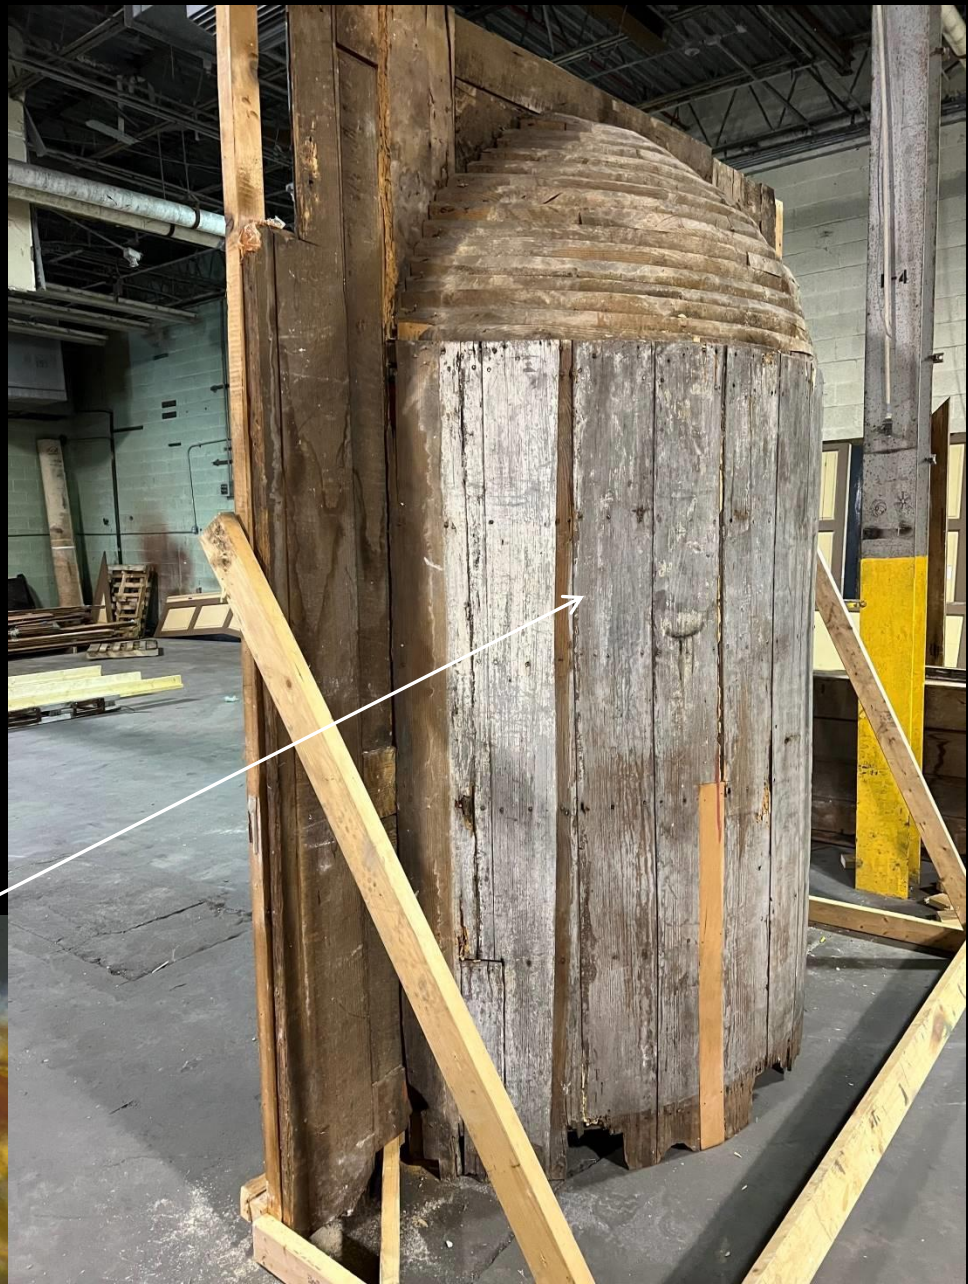
Limewashes on back of cupboard
